TOWN OF YEMASSEE SECTION 504 COMMITTEE MEETING

Town of Yemassee
Update List of ADA Compliance Issues
Town Owned Property
Inspection Completed 07-21-22

Town of Yemassee
Section 504 Committee

Current Conditions as documented July 21, 2022

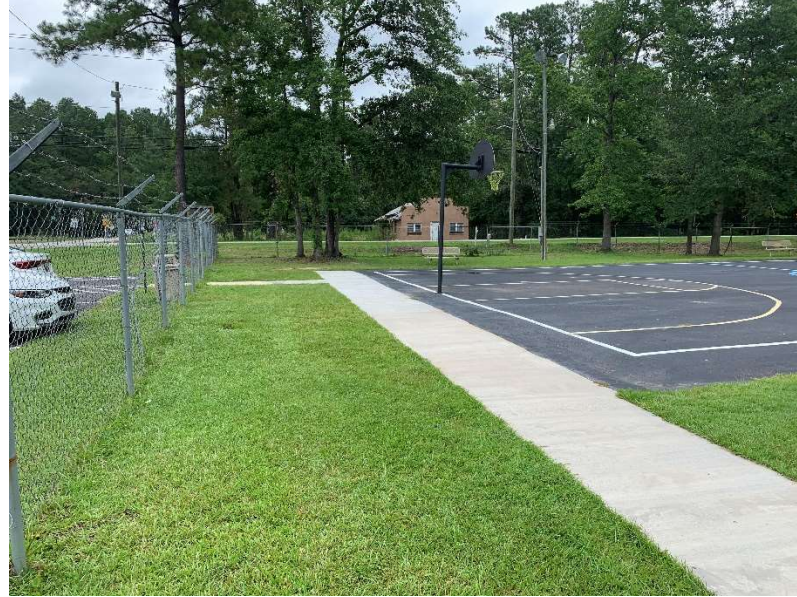
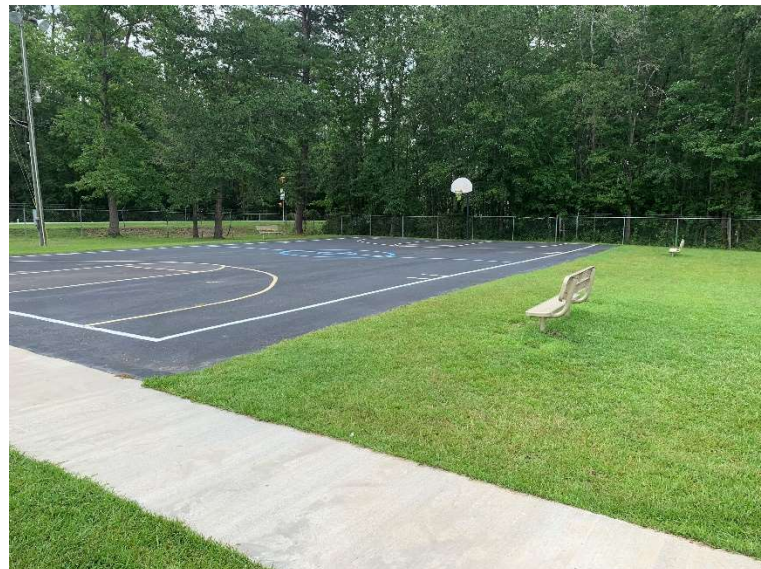
Willis Street Basketball Court
5 Willis Street South, Hampton County

Park received an overhaul in 2021 because of a PARD grant from SC PRT in the amount of \$25,000.00. The Basketball Court was resurfaced, a sidewalk poured from the new parking area to the court and further on to the restroom. Only recommendation is the addition of a handicapped viewing area on the side of the Basketball Court, which could be a small concrete slab where individuals in wheelchairs could observe.

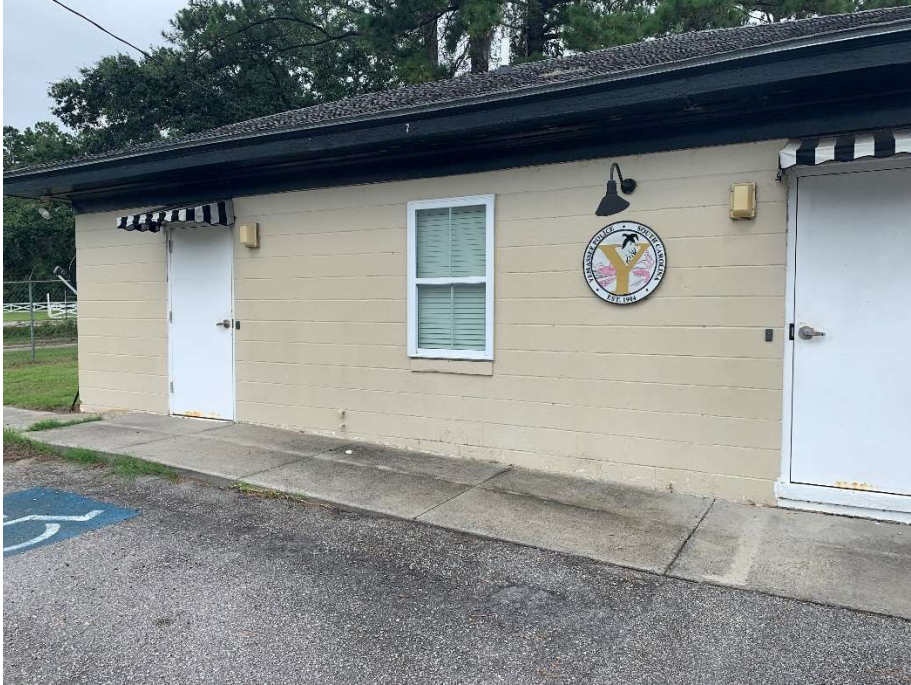
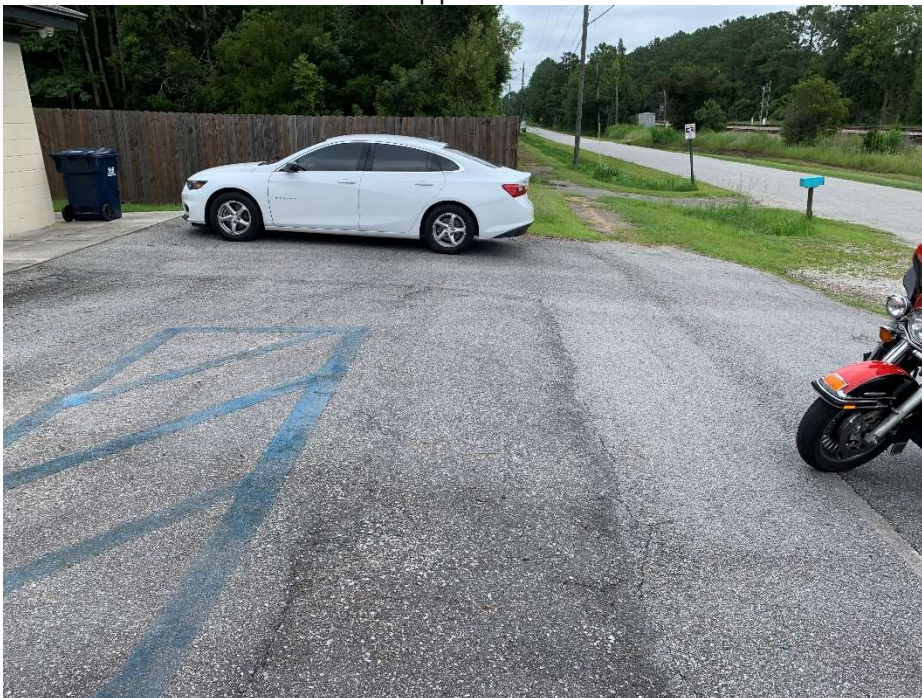
**Yemassee Police Department Downtown Annex
7 Railroad Ave N, Hampton County**

Parking lot is not at even grade. Significant work needed to address the lack of a level surface for handicapped individuals.

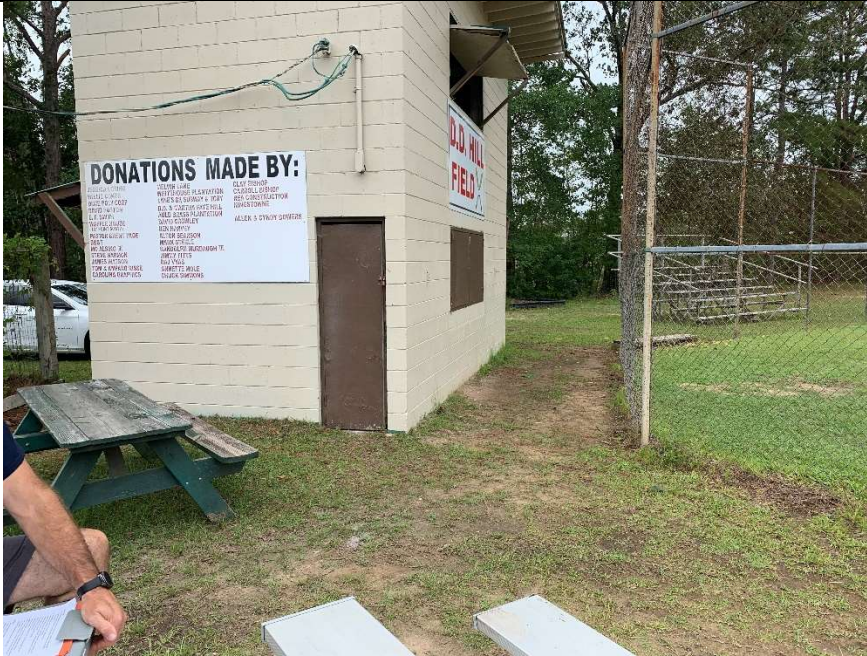
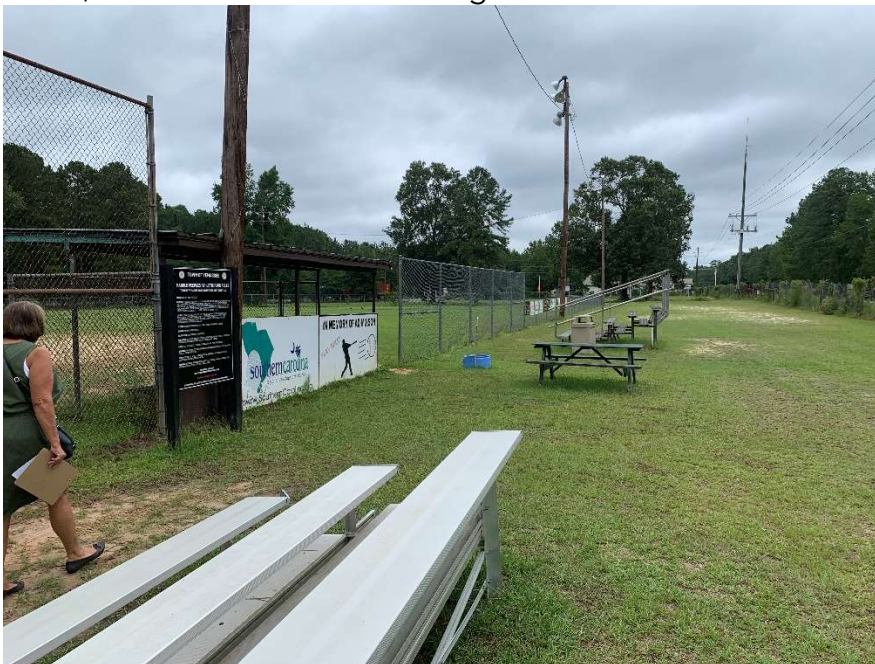
**Harold Peeples Athletic Park
29240 Pocotaligo Rd, Hampton County**

Park lacks any impervious surface for parking of vehicles to support offloading a wheelchair or similar accessibility device. Additionally, a sidewalk should be considered from the parking area to the concession stand, restroom area and viewing locations.

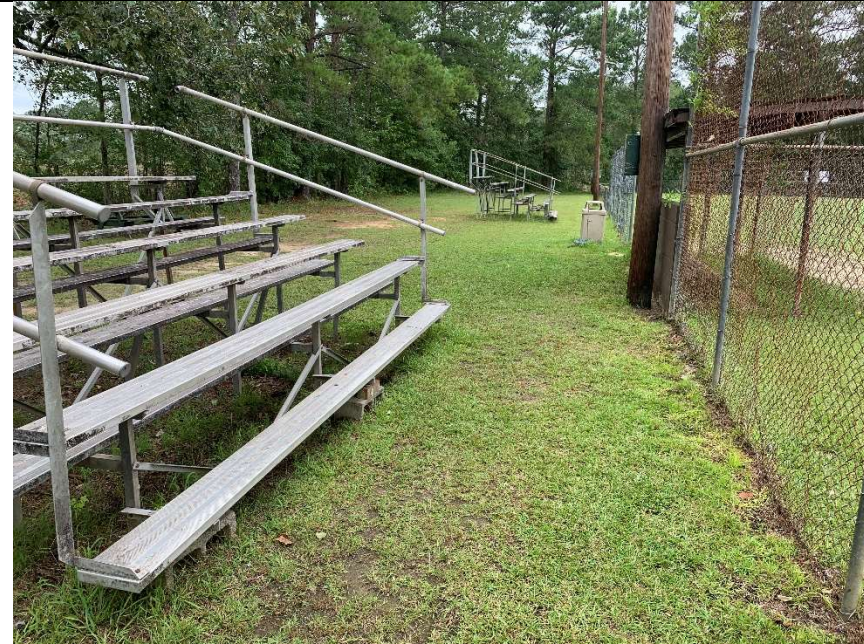
A concrete viewing area could be created near the existing bleachers on each side.

Both the "Home" and "Away" viewing areas need an impervious surface for handicapped viewing.

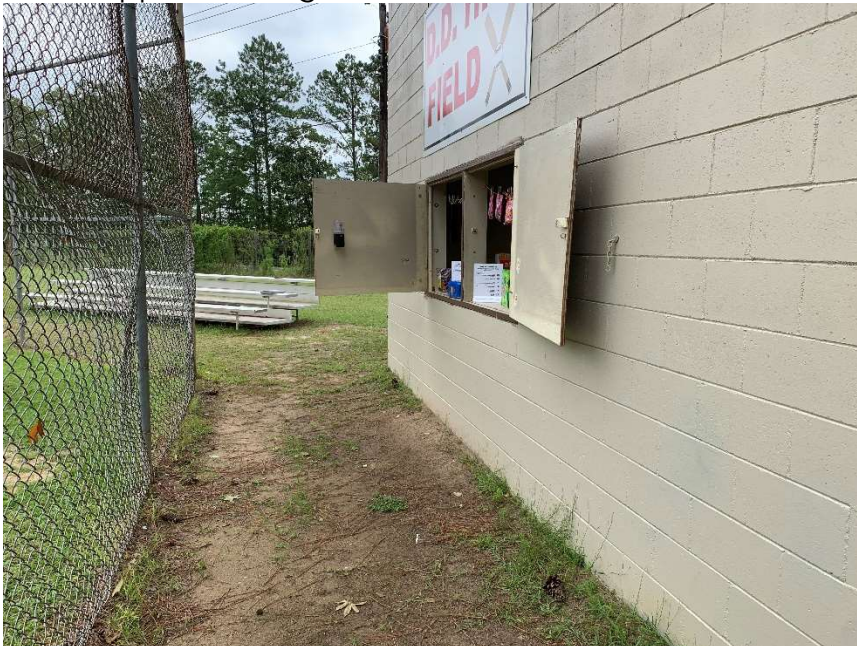
The current counter height of the Concession Stand is too high for a handicapped individual to receive service.

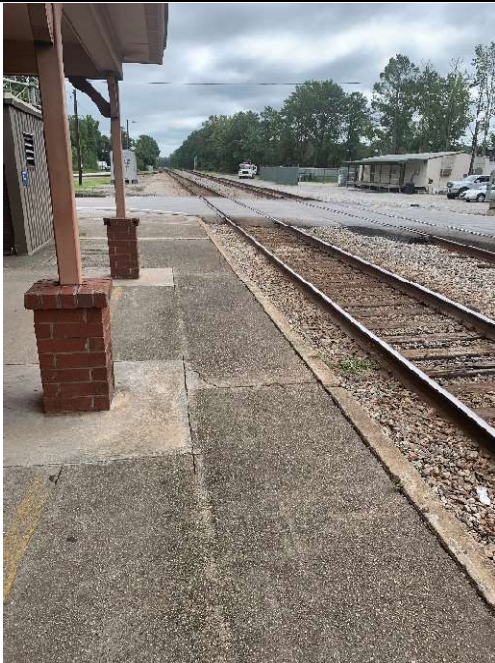
**Yemassee Amtrak Station
15 Wall St, Hampton County**

Passenger waiting areas outside lack the required rumble strips which alert a vision impaired individual that they are leaving a sidewalk.

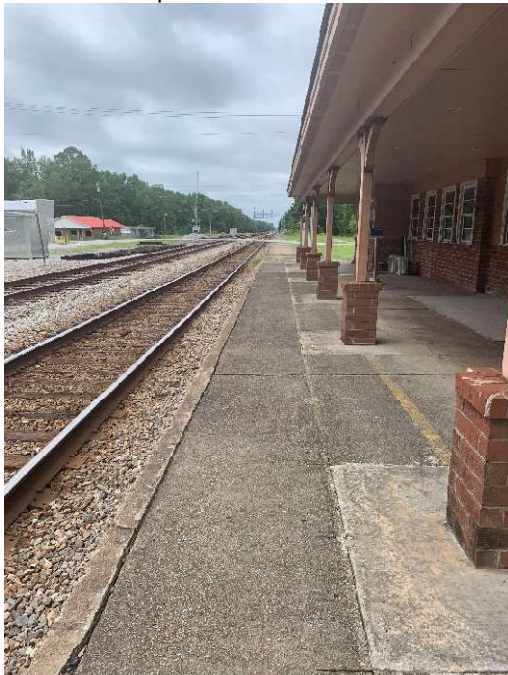
The strip should run the length of the platform. Consider reviewing the setup of platforms operated by the Metropolitan Transportation Authority (MTA) in the New York tri-state area.

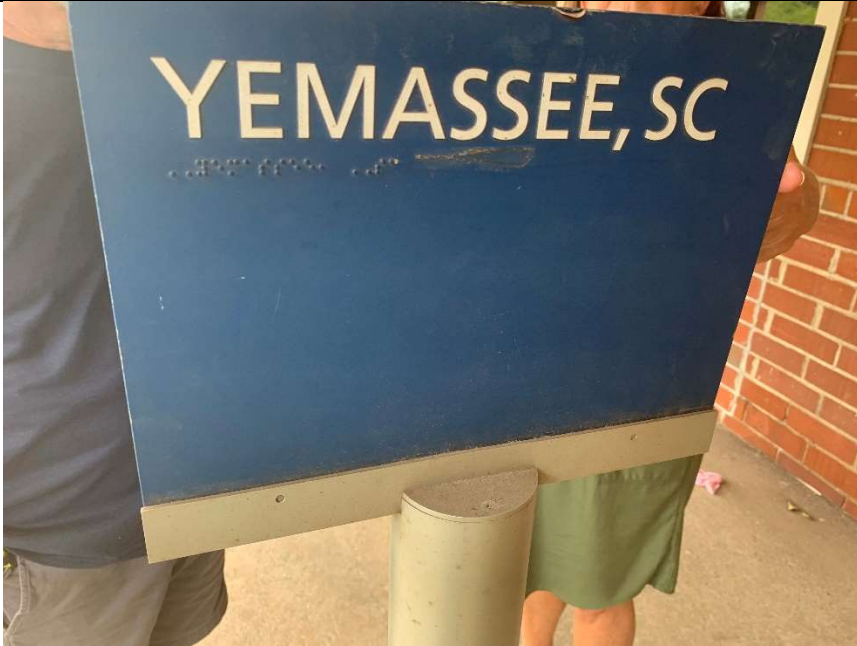
Braille signage has been filed down and needs to be replaced.

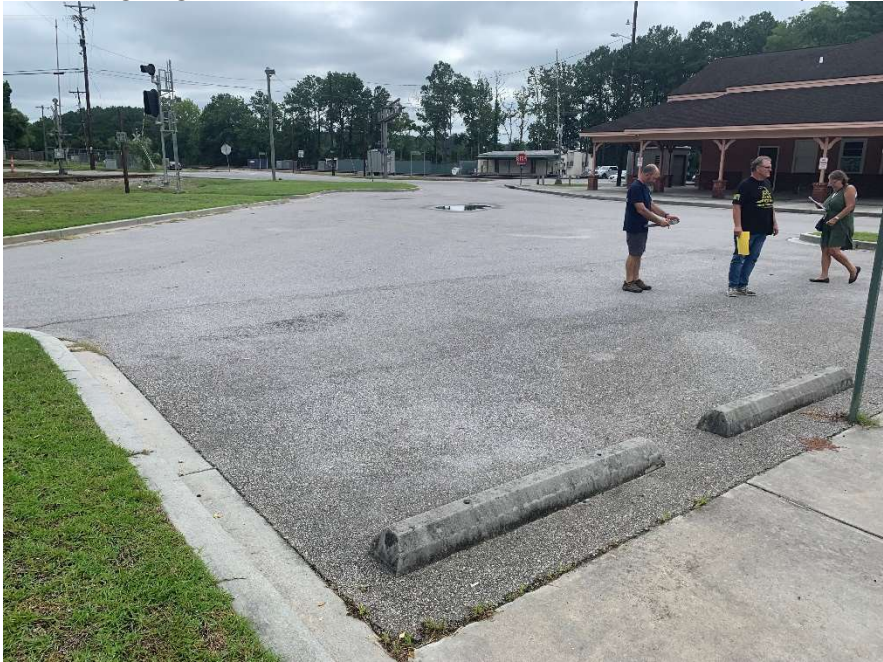
Parking lot requires re-stripping

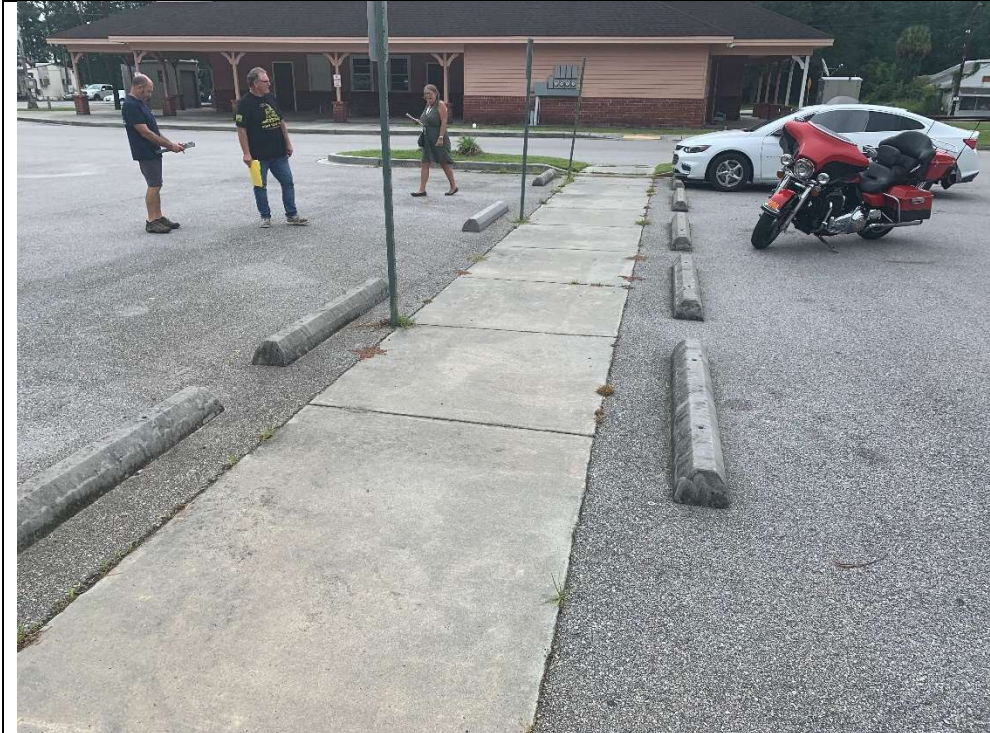
Parking area needs re-striping and the addition of a handicapped parking spot that is specifically van accessible.

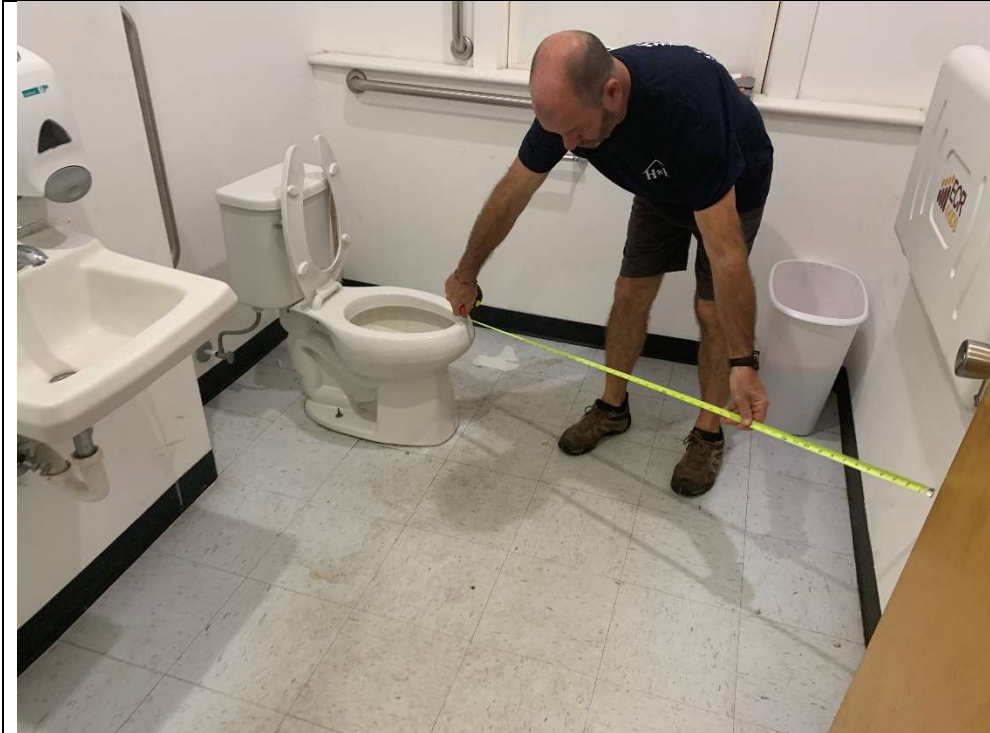
The train station currently has two unisex restrooms. One is compliant with ADA requirements while the other (pictured here) would need additional work to become in compliance.
